Coastal Protection and Restoration Authority of Louisiana

2010/2011 Annual Inspection Report

BLACK BAYOU HYDROLOGIC RESTORATION PROJECT (CS-27)

May 4, 2011
Calcasieu and Cameron Parishes

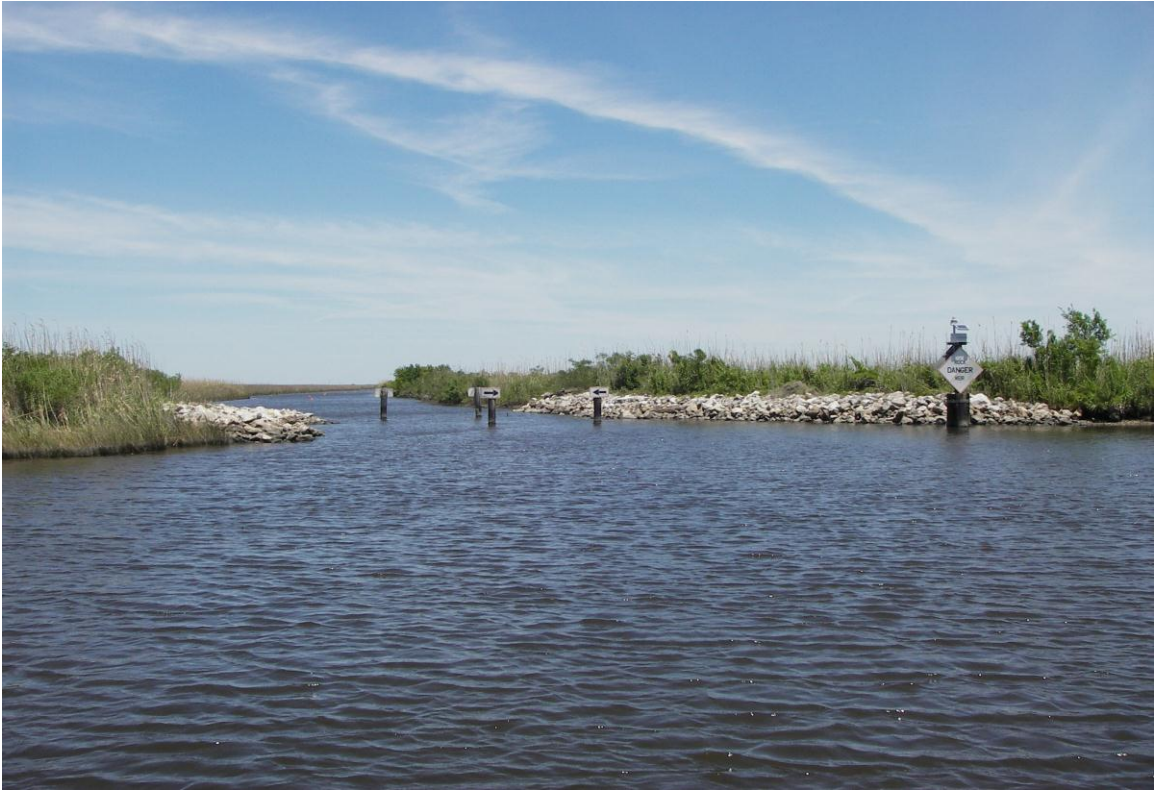
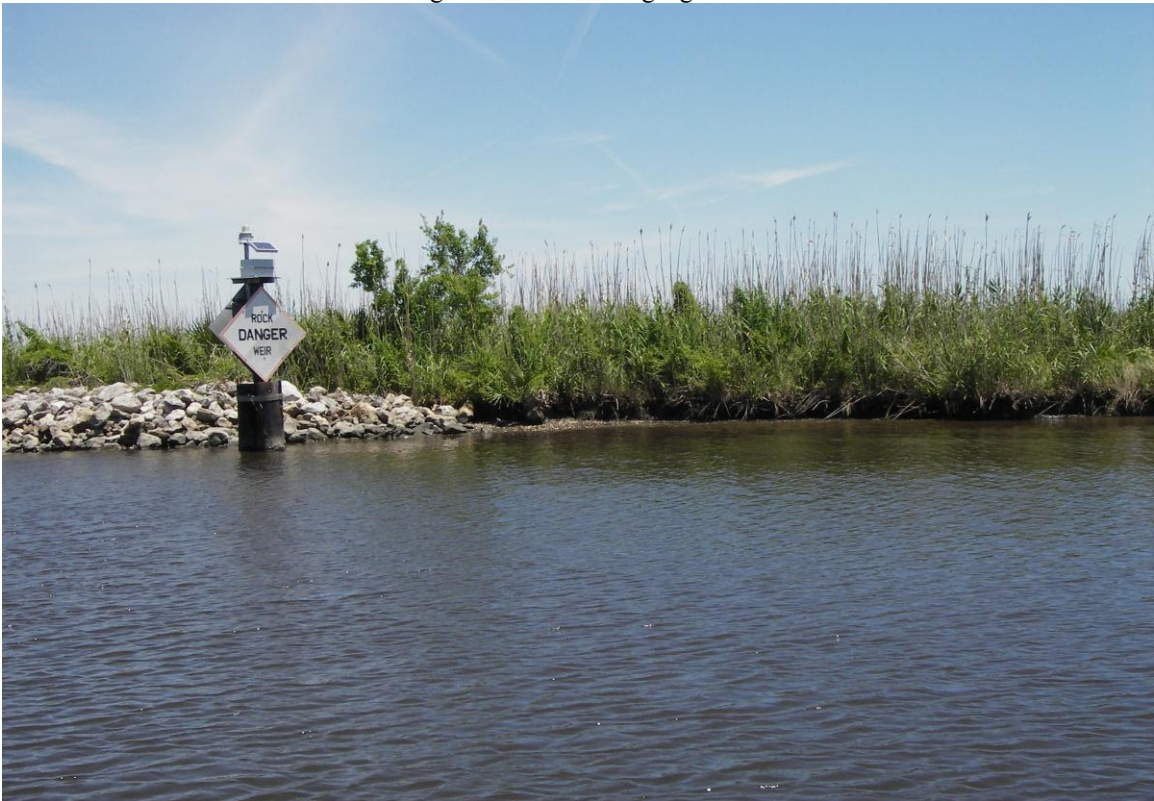
The rock weir is in excellent condition. Signage is stable. The erosion on the SE will continue to be monitored, but has stabilized. No need for maintenance at this structure. Conditions of the Navigational Aid Lights were last inspected on 3/3/11. (Photos: Appendix B, Photos 1-2)

Photo 1—Navigational Aids and signage at Block's Creek

Photo 2—southeastern corner of Block's Creek Structure

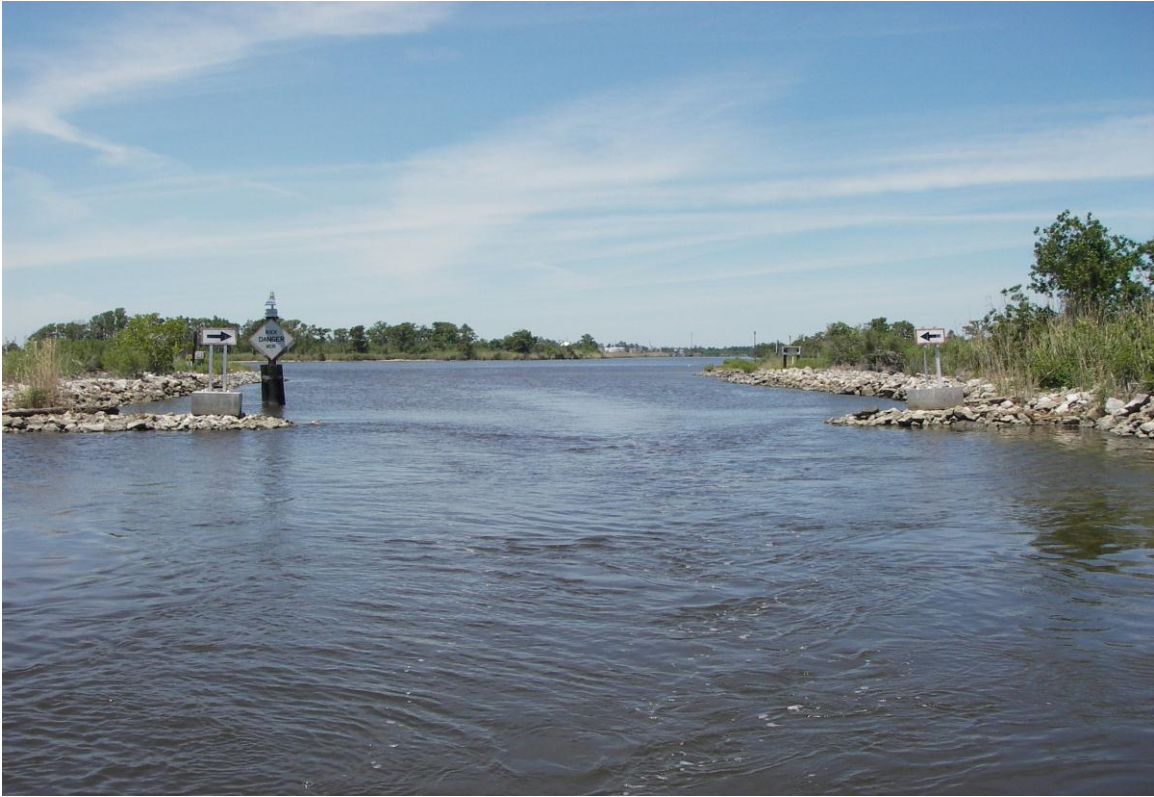
The weir is in good condition. The scouring along the canal banks inside of the weir at the end of the dike has stabilized. Arrow signs installed as part of the last maintenance event are working well. No need for any maintenance at this time. The Navigational Aid Lights were last inspected on 3/3/11. (Photos: Appendix B, Photo 3)

Photo 3—Burton Canal Structure

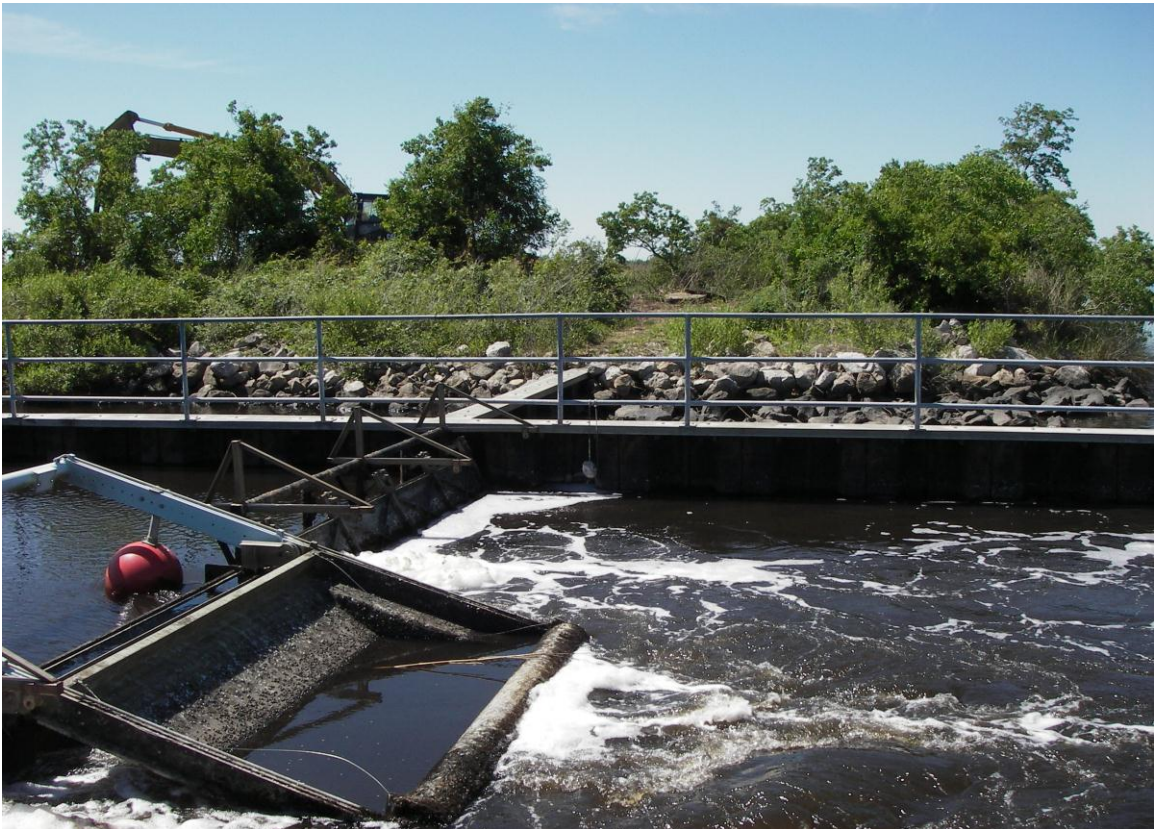
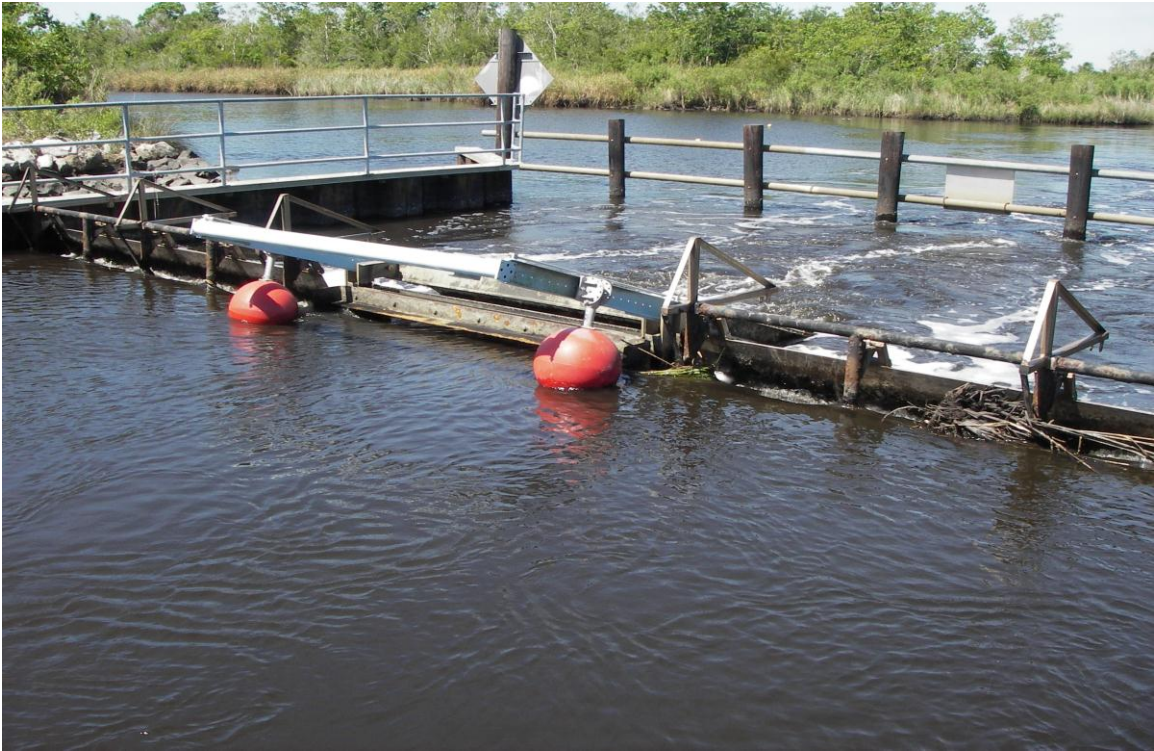
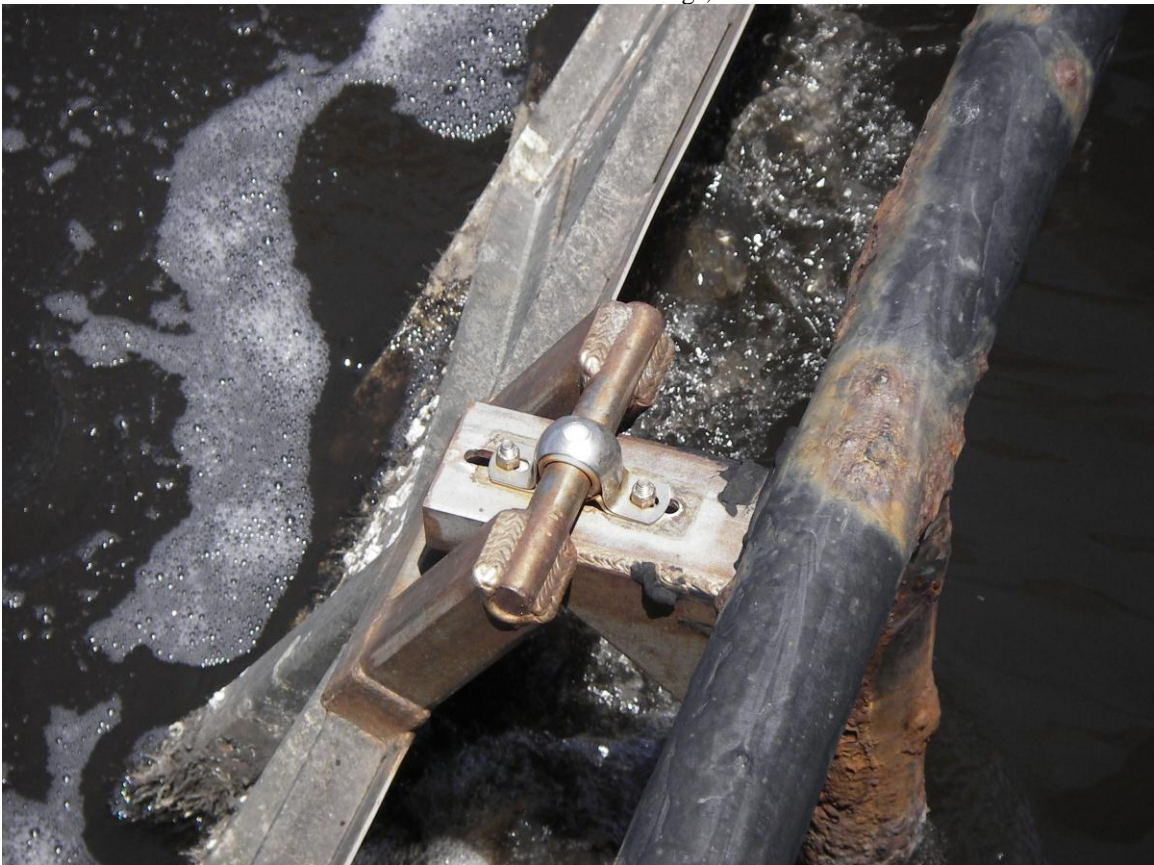
The structure itself is in very good condition. The pillow blocks replaced during the last maintenance event, signage, railings, wingwalls, etc. are in excellent condition. No need for maintenance. (Photos: Appendix B, Photos 4-6)

Photo 4—SRT Gate

Photo 5—SRT Gate railings, etc.

Photo 6—New pillow block on SRT Gate flap

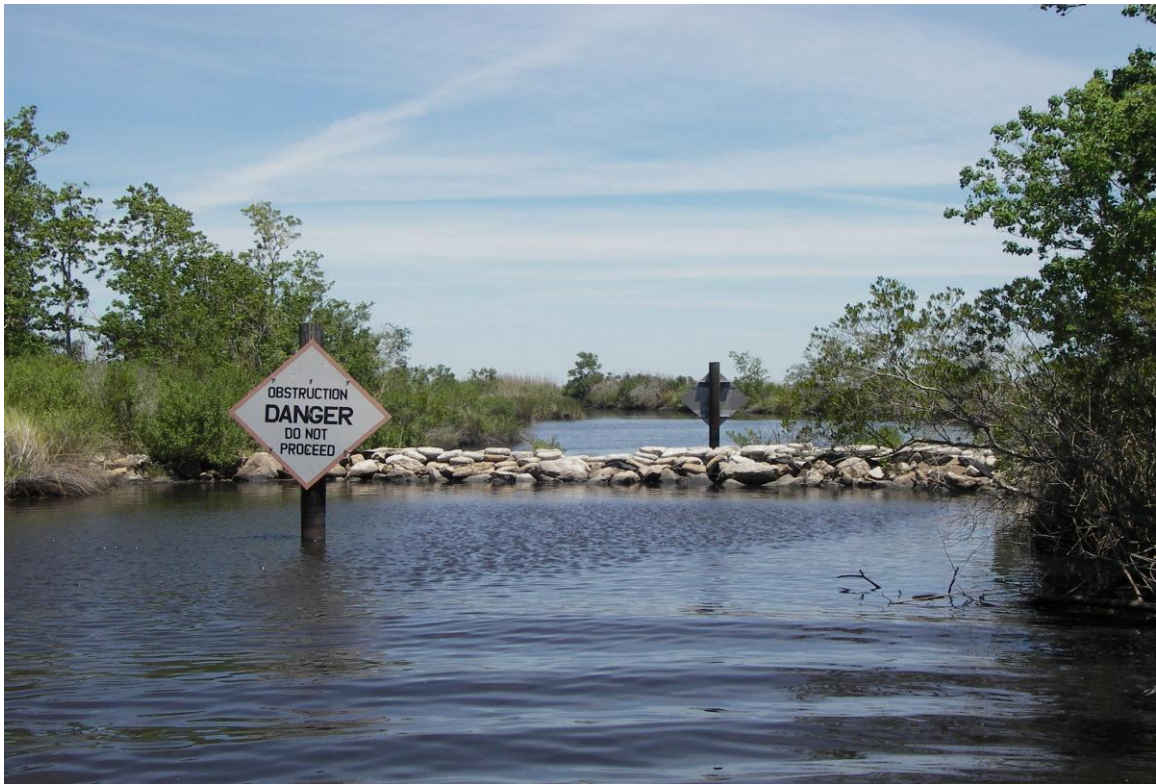
The rock dike, as repaired with the concrete sacks is functioning as designed. Tie-ins are stable. No maintenance required. (Photos: Appendix B, Photo 7)

Photo 7—repaired plug near SRT Gate

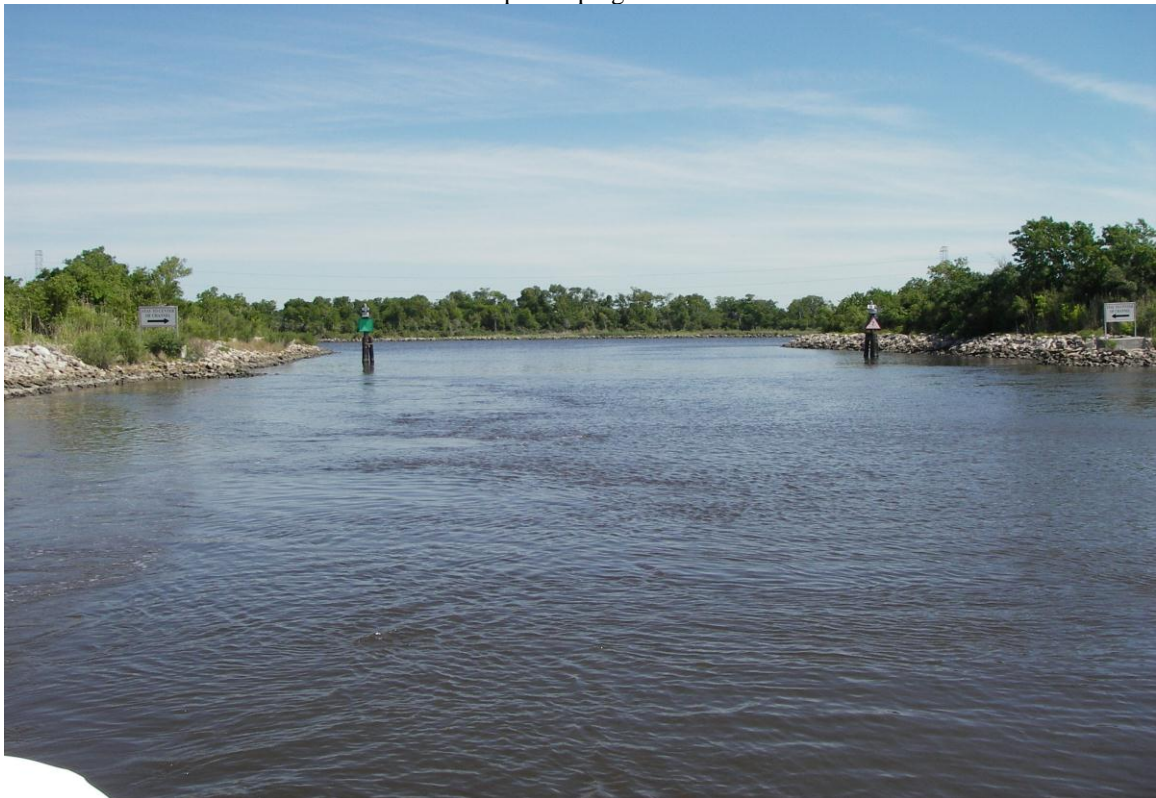
This component is in immediate post construction condition. No need for maintenance at this time. Conditions of the Navigational Aid Lights are inspected quarterly and were last inspected on 3/3/11. (Photos March, '06: Appendix B, Photo 8)

Photo 8—Black Bayou Cut-off Canal structure

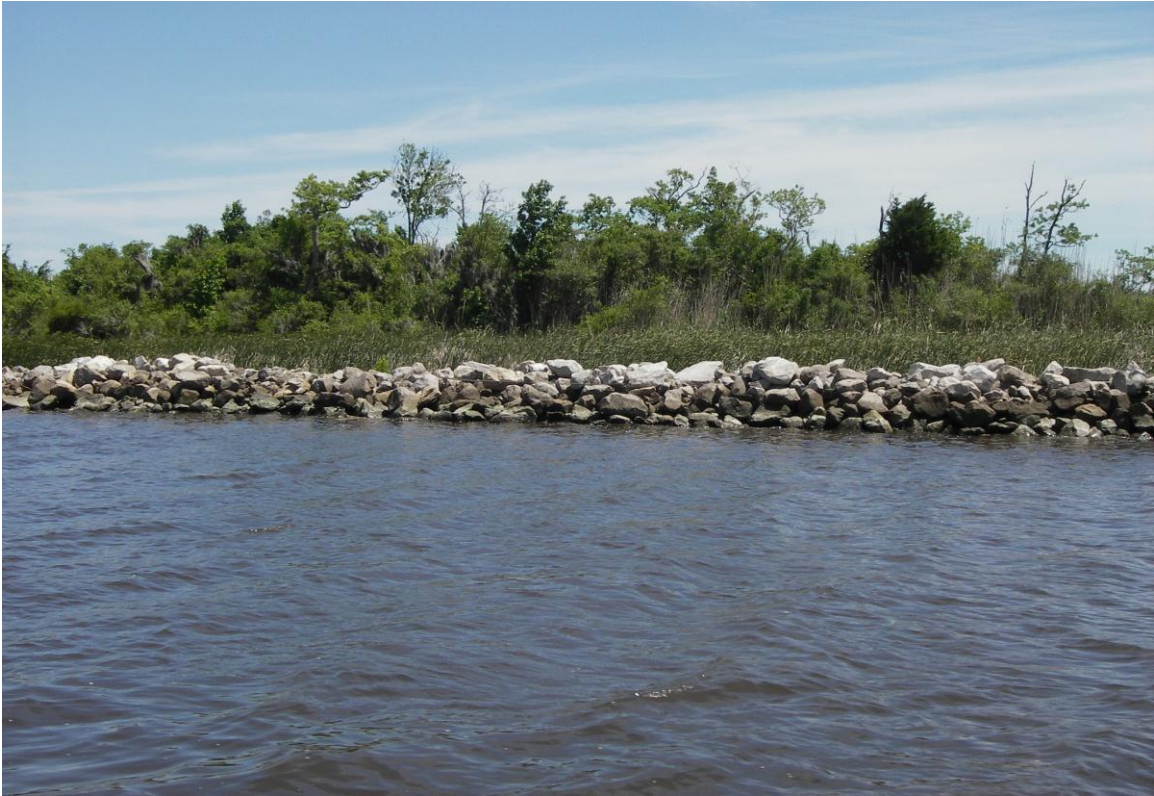
Photo 9—Typical section of rock dike

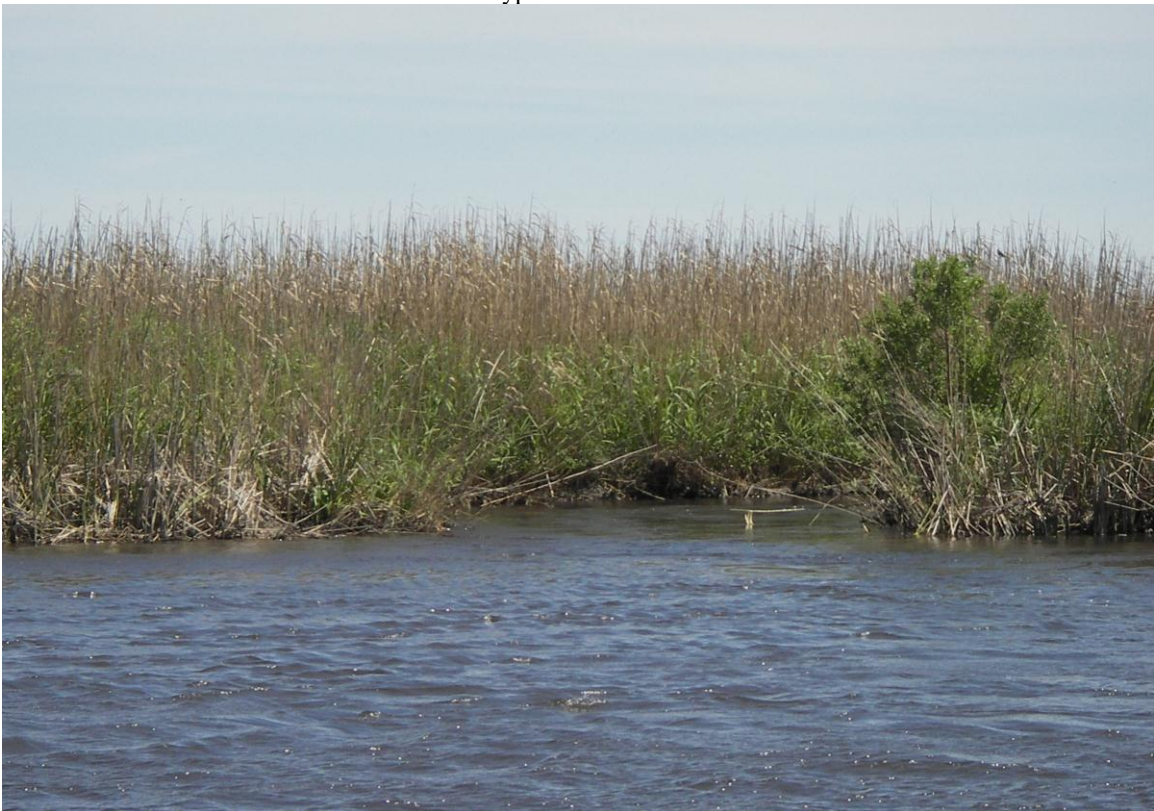
Tie-ins on both the east and west end of the dike are stable. As mentioned in previous inspections, the warning signs at both the Vinton and Black Bayou closures have been stolen. The spoil placed behind the rock dike at the Black Bayou Canal has washed away on the western end. The repair to the dike across from the Vinton Canal with concrete sacks is working extremely well. There are new breaches at the western closure's eastern end and on the 2nd closure from the west on both sides. The alligator moved slightly over to the west of the repair from the last maintenance event and has caused another breach. This breach is approximately 6 feet wide and 4 feet deep. On the eastern side of this closure, the breach is approximately 2 feet wide and has significant flow. Terraces being constructed by DU will be placed in the area to help alleviate the problem. This should be completed by mid July, 2011. (Photos: Appendix B, Photos 9-12)

Photo 10—breach around closure

The Black Bayou Hydrologic Restoration Project constructed components are in excellent condition as a result of the last maintenance event and do not need any other maintenance at this time. The newly discovered breaches should be addressed by Duck's Unlimited. It was learned that the alligator crossing that was repaired during the last maintenance event may have been designed incorrectly. It has since been learned that alligators will cross areas such as this at the narrowest point, regardless of the elevation. The crossing repaired was wide and low and should have been higher and narrower. This will be considered during future events as such as this. Concrete sacks work extremely well in areas where small sections of rock dike need repair and should be considered in these situations. Warning signs in areas of severe current caused by installation of rock or sheet pile weirs should always be included. These signs should be installed in concrete blocks out of the way of traffic since this has proven to be very effective. Also, railings or fences around water control structures should be considered.

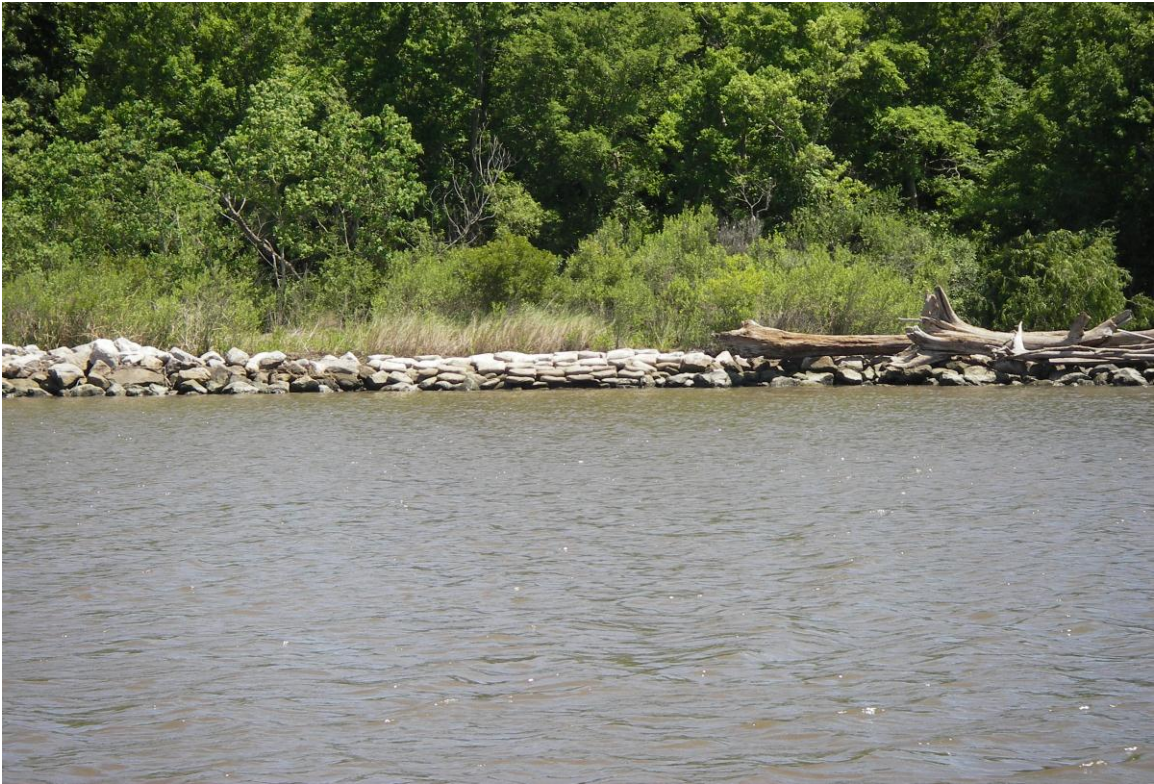
Photo 11—repaired gap in rock dike at E. end of Vinton Canal Closure

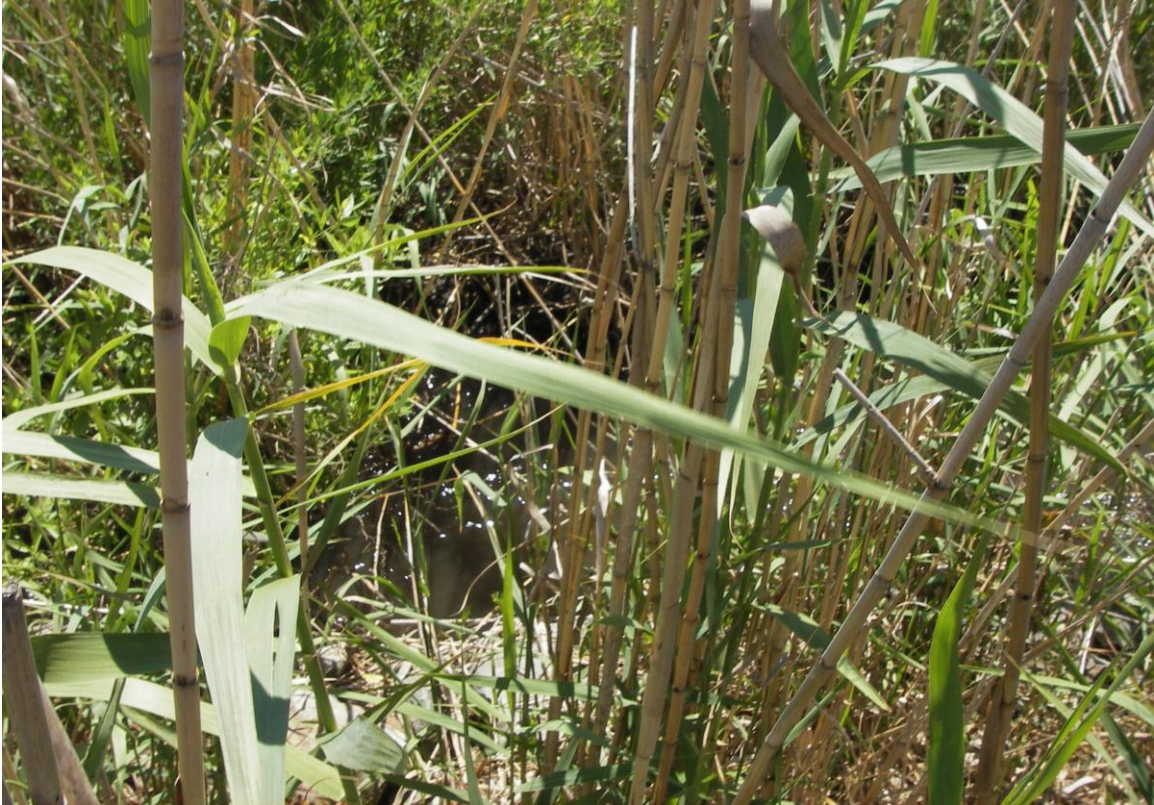
Photo 12—breach around closure
